# Appendix A

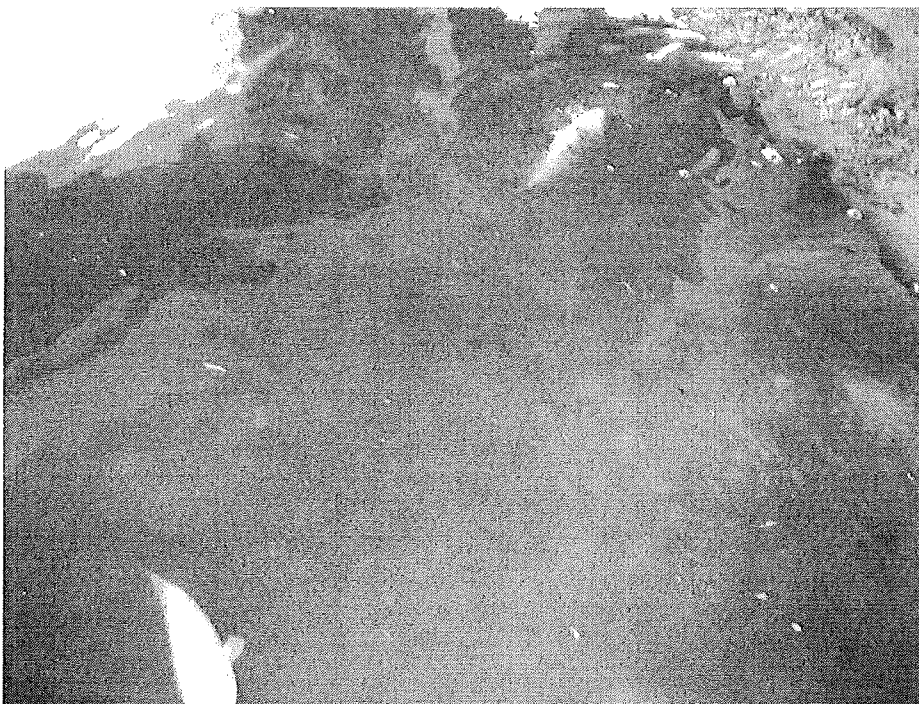
Picture 1: Dead fish at site#1 Bayou Casotte Parkway Bridge 081913

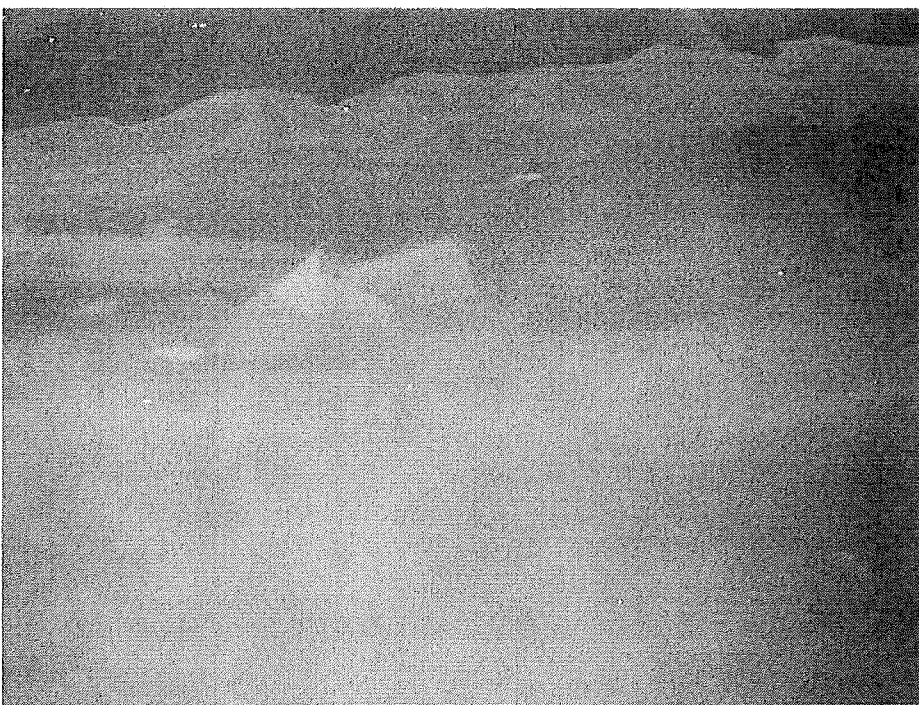
Picture 2: Dead fish lying along the bottom at site#1 Bayou Casotte Parkway Bridge 081913

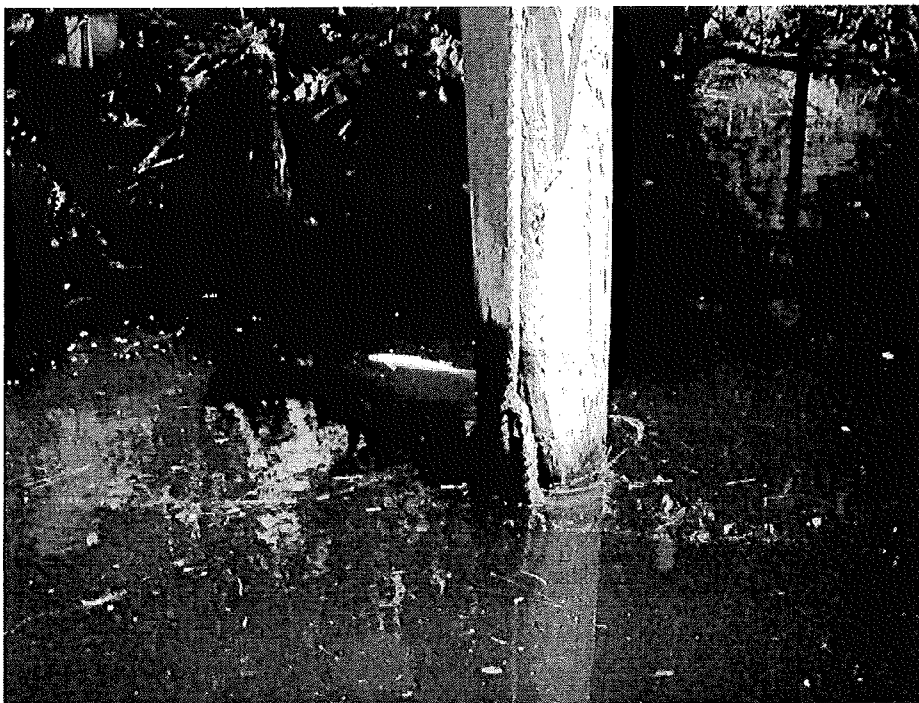
Picture 3: Dead Stripped Mullet near dock right before site#1 Bayou Casotte Parkway Bridge 081913

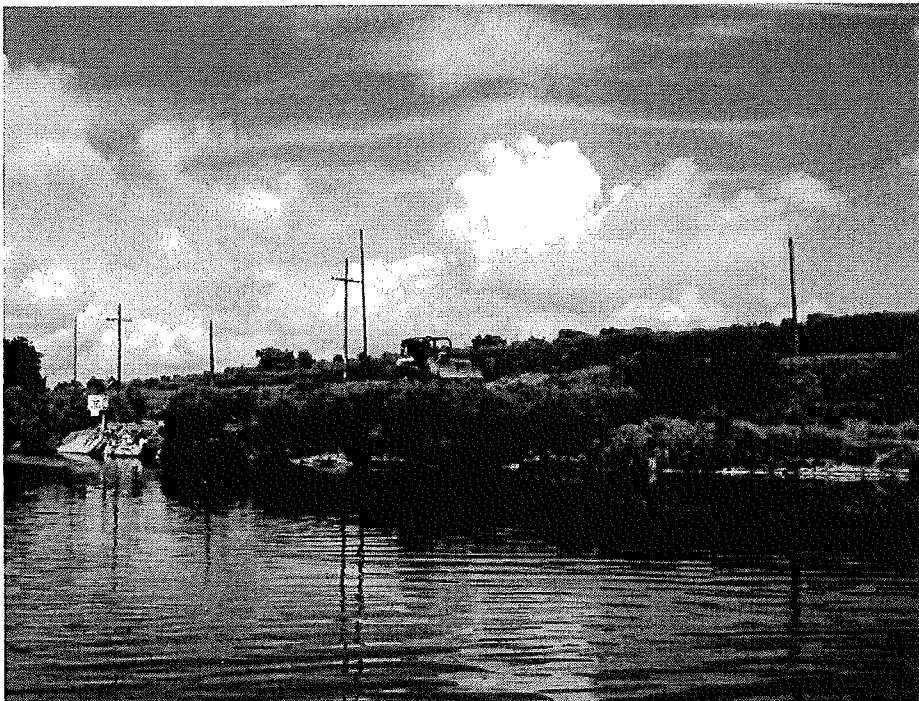
Picture 4: At site#2 Concrete Ditch/Break. Heavy machinery moving dirt to repair dike. 081913

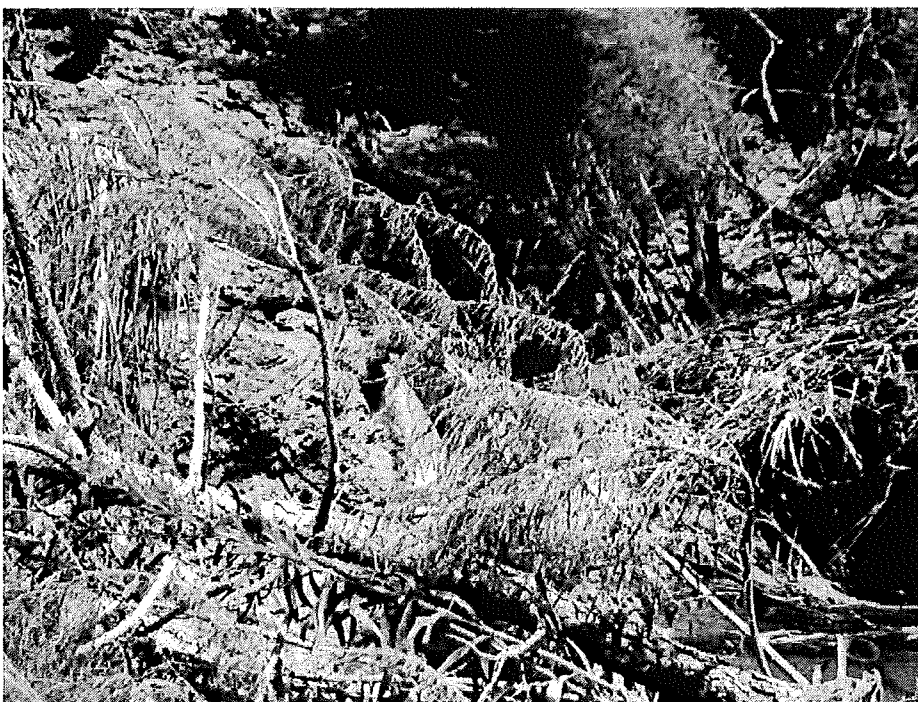
Picture 6: Liquid discharging into Bayou Casotte at site#2 Concrete Ditch/Break. 081913

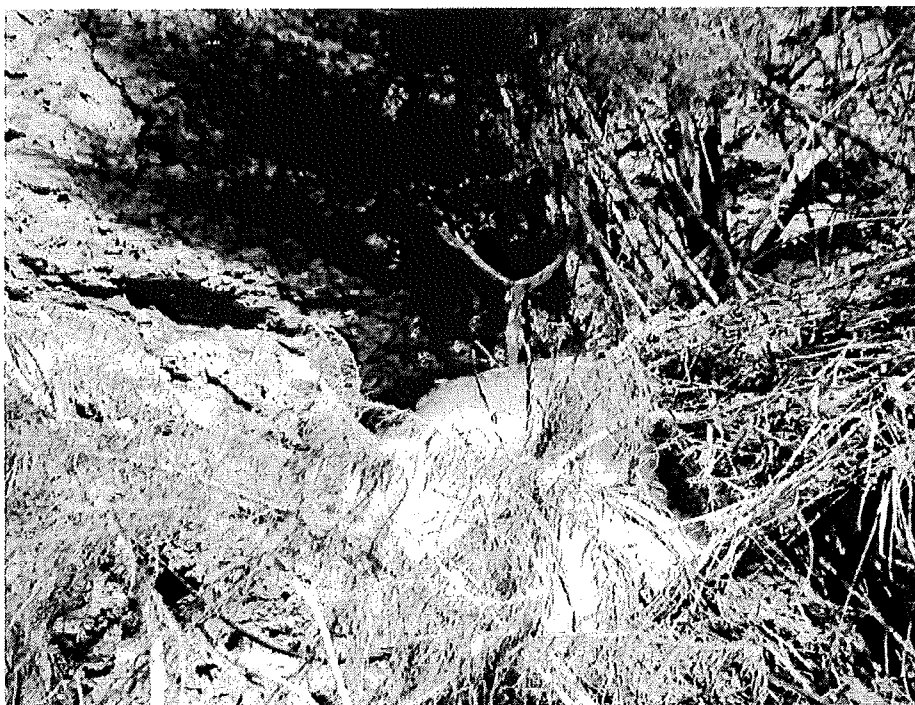
Picture 7: Liquid discharging into Bayou Casotte at site#2 Concrete Ditch/Break continued. 081913

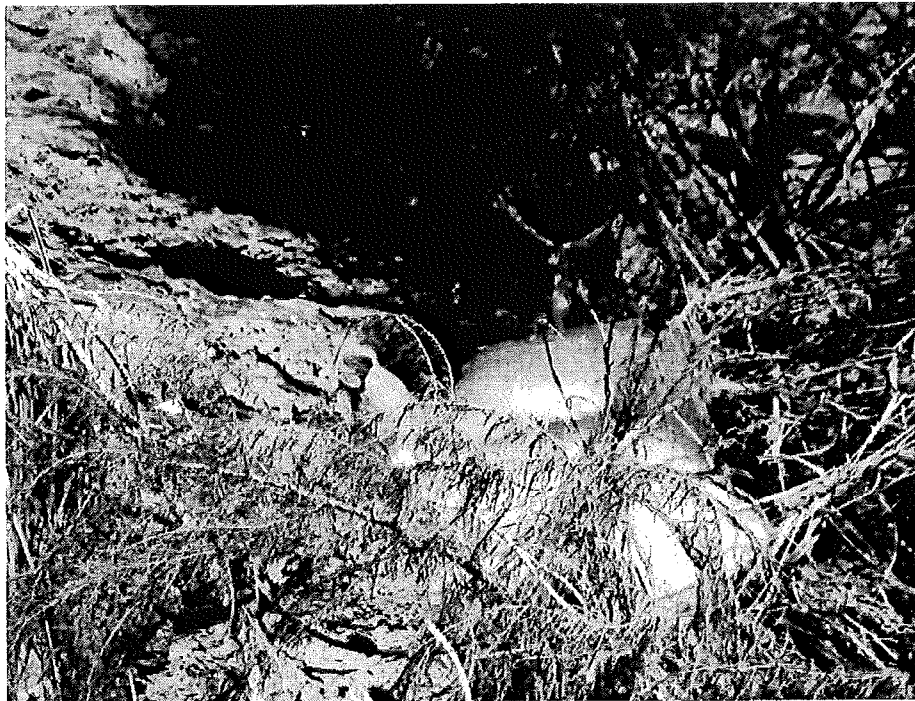
Picture 8: Liquid discharging into Bayou Casotte at site#2 Concrete Ditch/Break continued. 081913

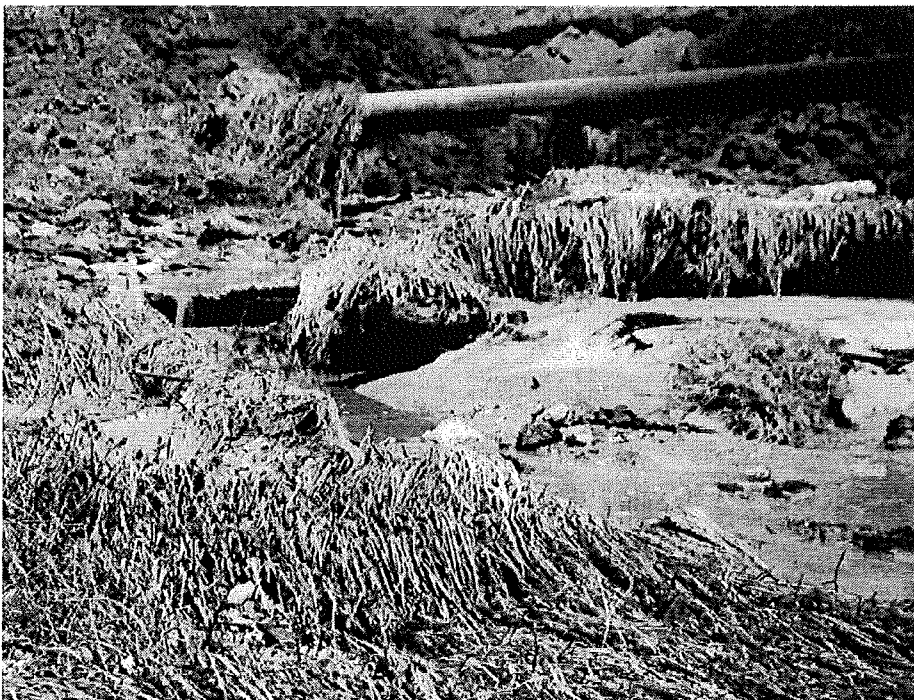
Picture 9: Liquid discharging into Bayou Casotte at site#2 Concrete Ditch/Break continued. 081913

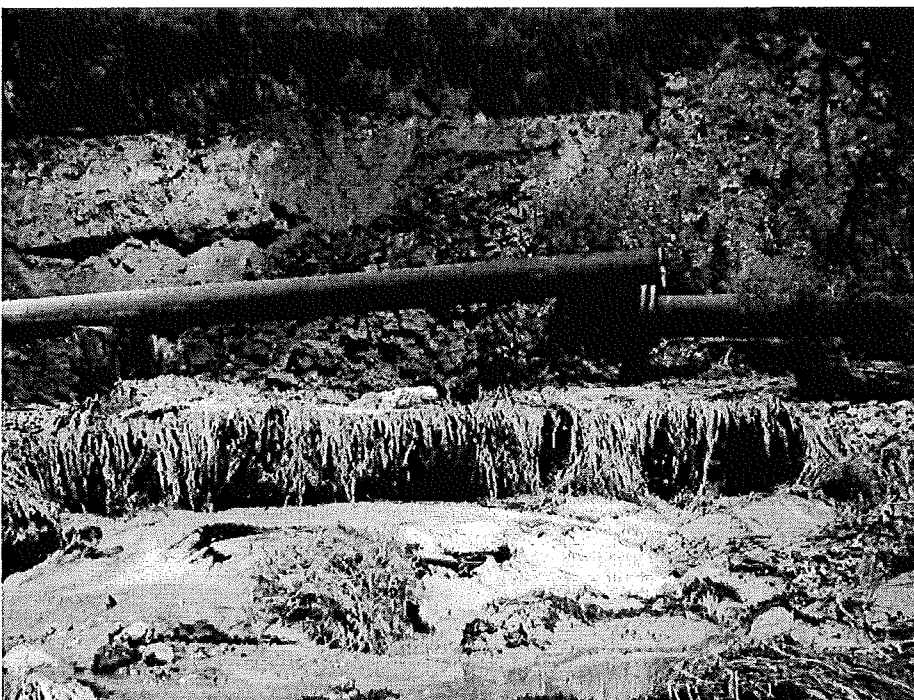
Picture 10: Liquid discharging into Bayou Casotte at site#2 Concrete Ditch/Break continued. 081913

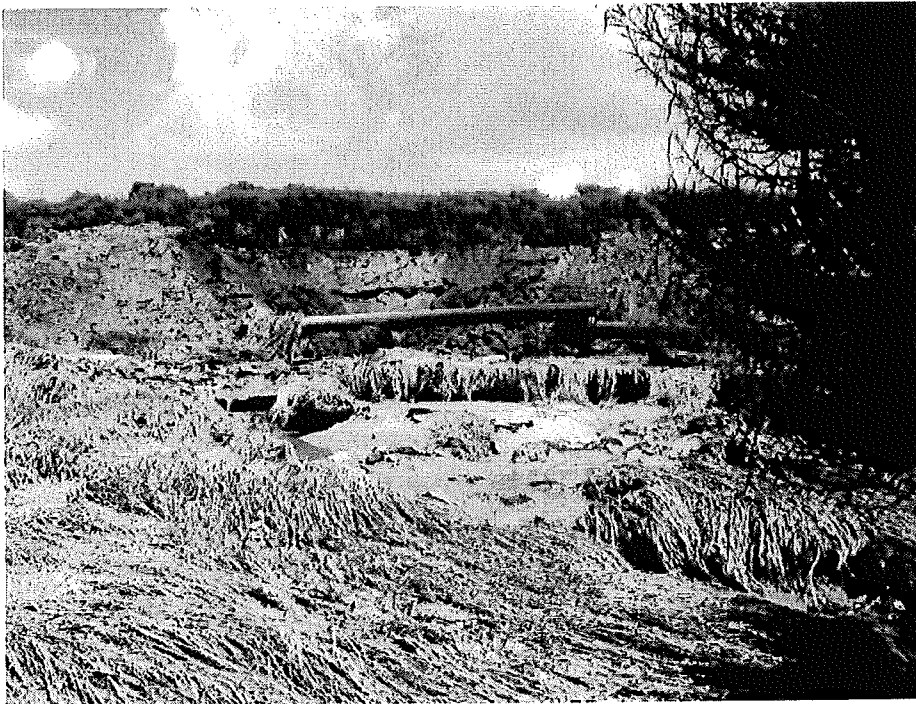
Picture 11: Liquid discharging into Bayou Casotte at site#2 Concrete Ditch/Break continued. 081913

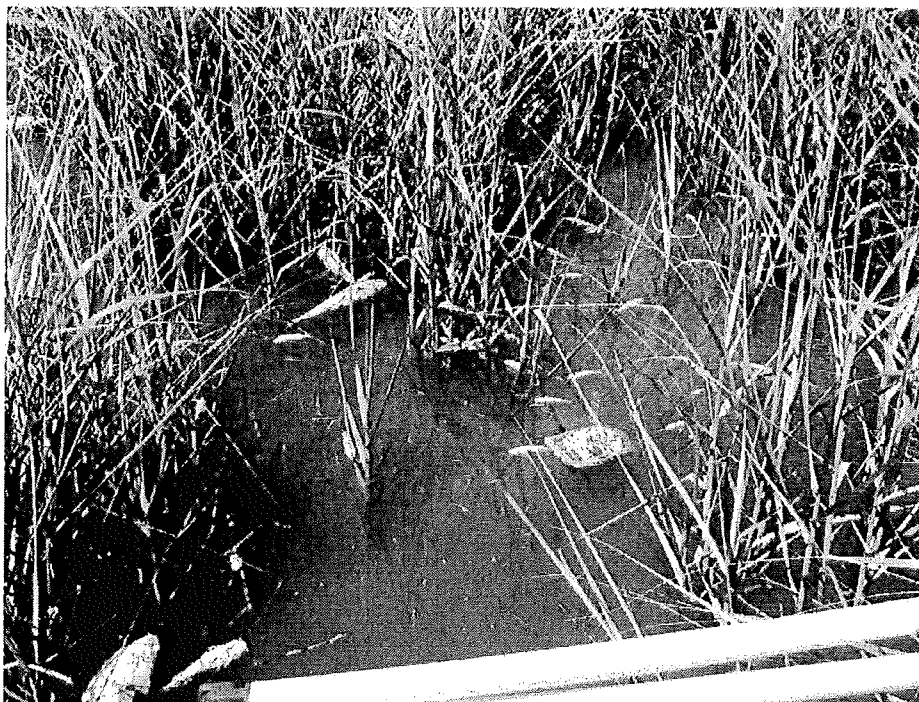
Picture 13: Dead fish at site#3 MS Phosphates, Inc. outfall 081913

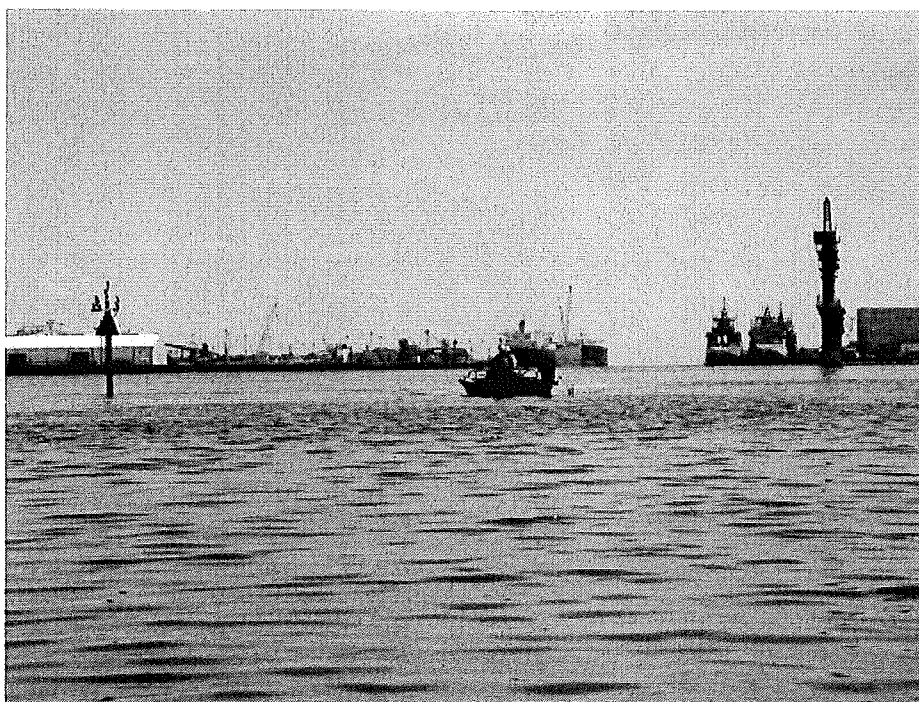
Picture 14: MS Phosphate crew boat collecting dead fish near site#4 Channel Marker 12 near boat ramp 081913

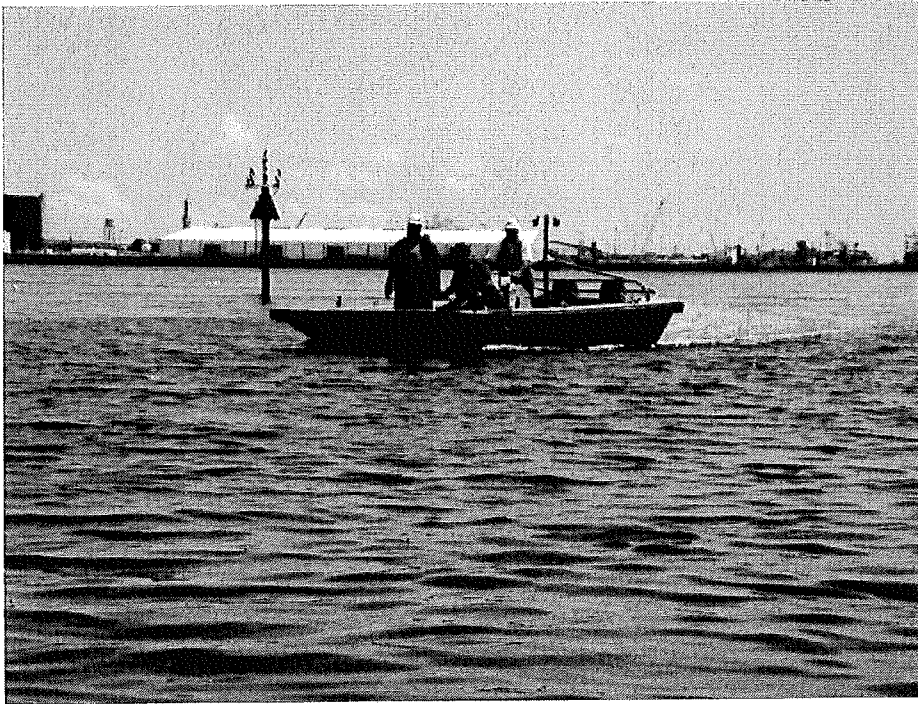
Picture 15: MS Phosphate crew boat collecting dead fish near site#4 Channel Marker 12 near boat ramp continued 081913

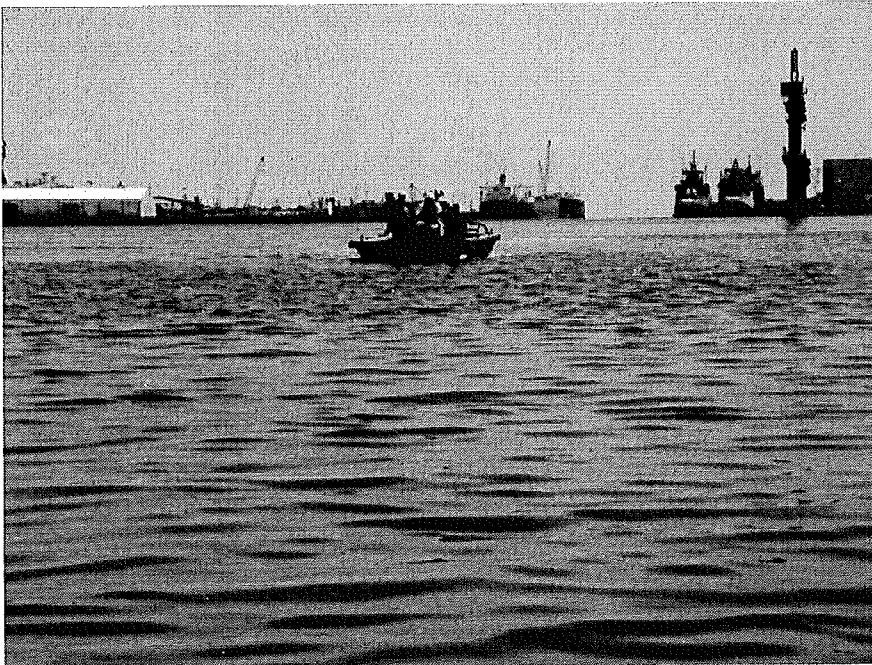
Picture 16: MS Phosphate crew boat collecting dead fish near site#4 Channel Marker 12 near boat ramp continued 081913

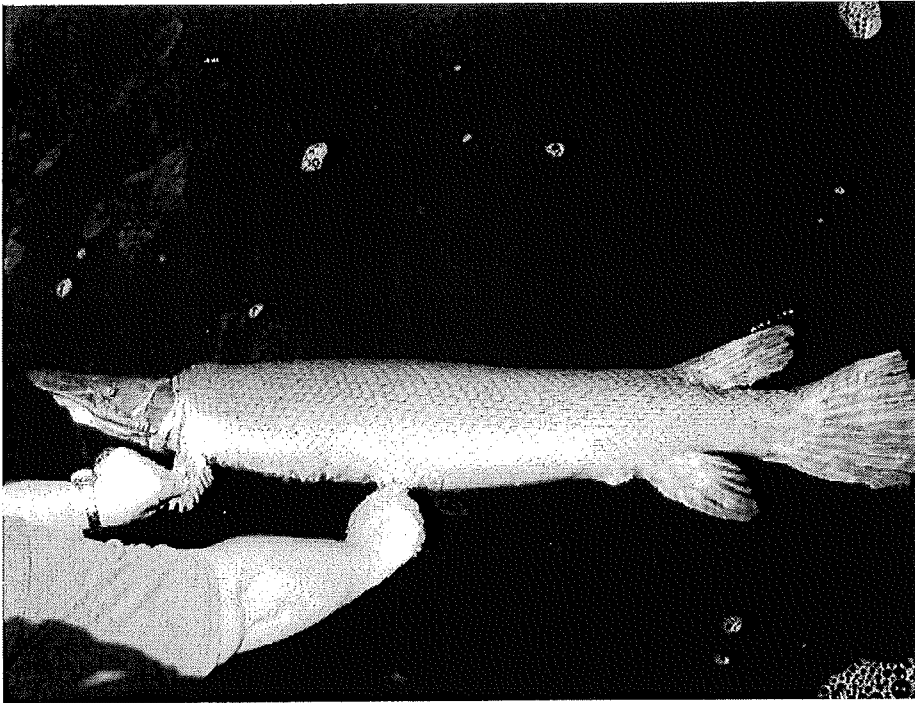
Picture 19: Dead gar found floating mid channel between site#4 and VT Halter dock 081913

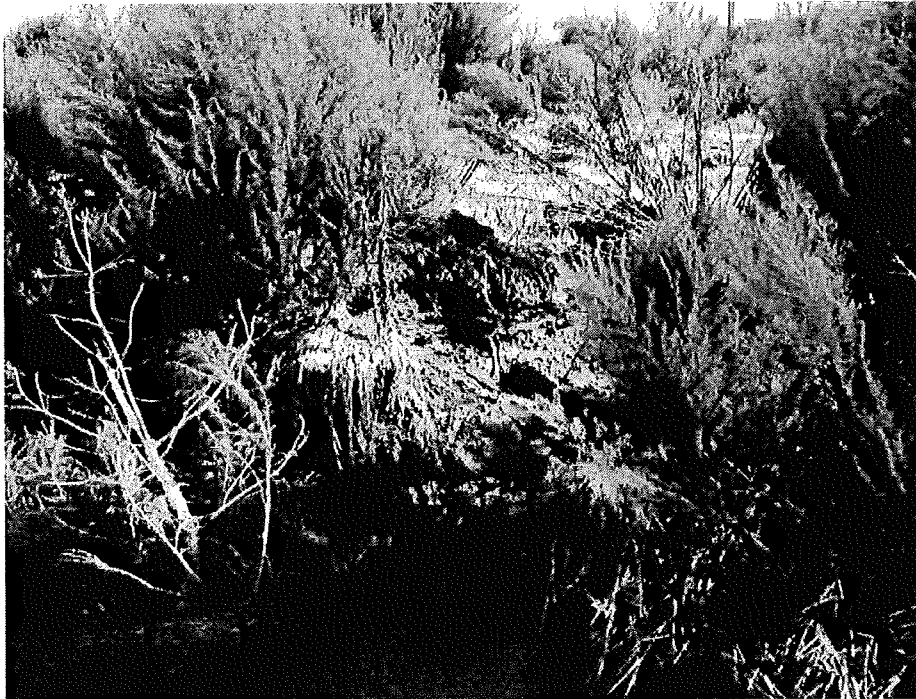
Picture 24: 082013 Flow continues down the hill at site#2 Concrete Ditch/Break

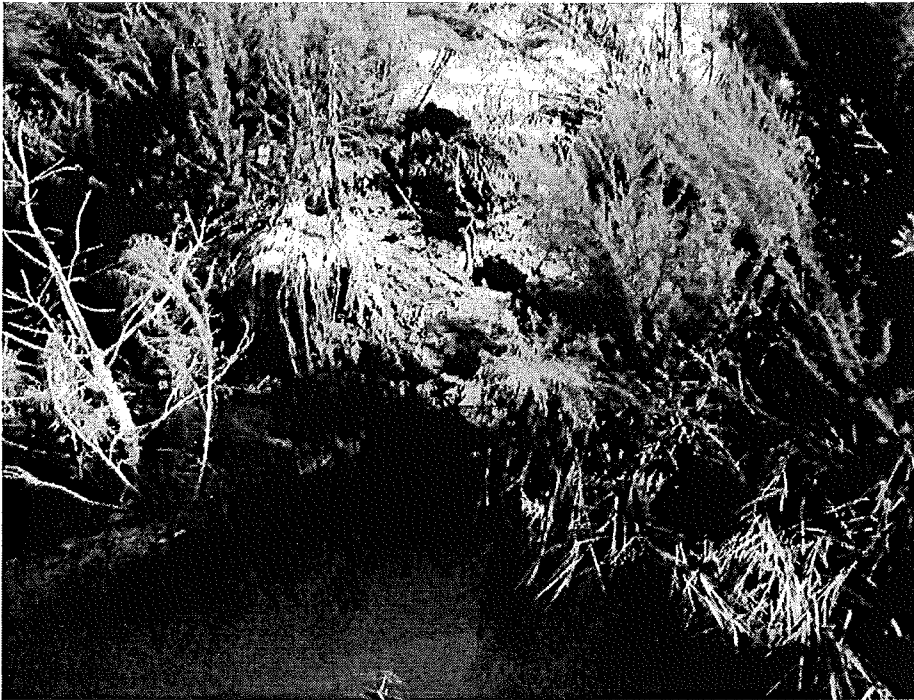
Picture 25: 082013 Flow continues down the hill at site#2 Concrete Ditch/Break

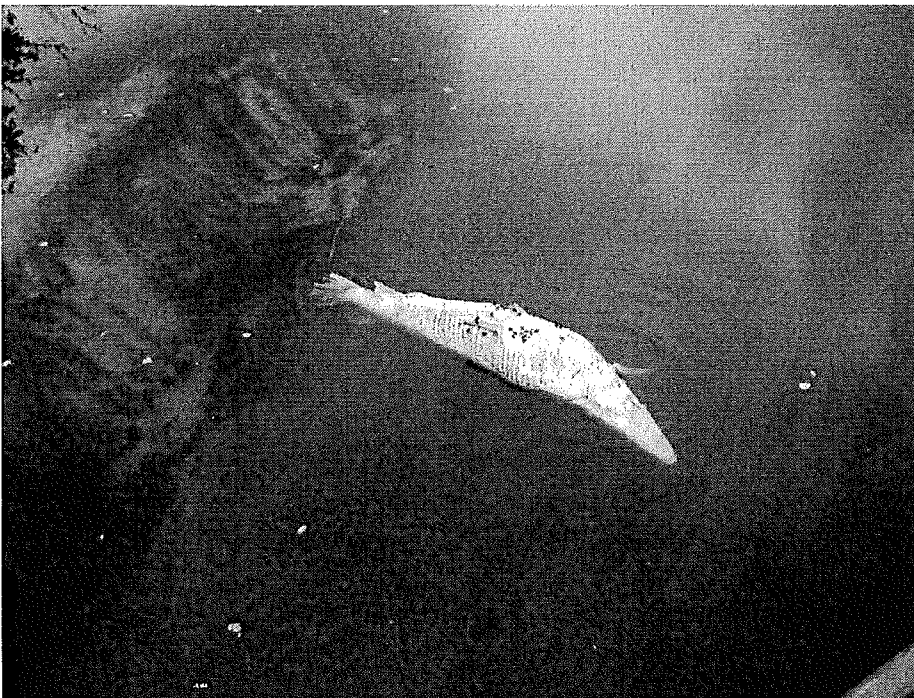
Picture 26: Second dead gar. Approx. 3ft in length.

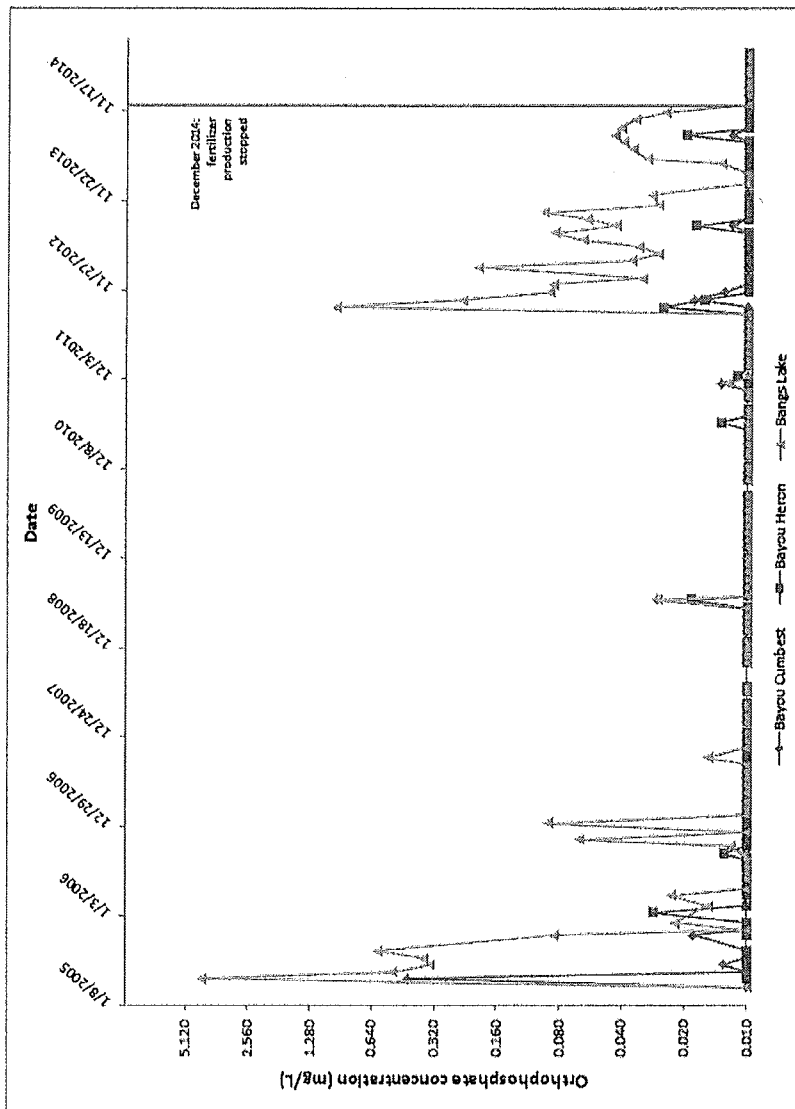
# Graph of Phosphorus levels at three locations the Grand Bay NERR

Graph shows levels of phosphorus (measured by orthophosphate) in the water at three sampling stations (locations indicated on the map on the following page). Phosphate in Bangs Lake spiked after the levee break in 2005, then decreased over several months to what we consider typical levels, with only occasional, short-lived increases. After hurricane Isaac in August 2012, phosphate spiked again, and stayed high through November 2014 (>2 years). Since the plant stopped production, phosphate has been low again
